# Characterizing PCB contamination in Painted Concrete and Substrates: The “Painted History” at Army Industrial Sites

ERDC-EL Environmental Engineering

- **July 2008** –Collected paint and substrate samples of 3 inactive non-explosive building lines slated for demolition, in order to determine if the buildings contained PCBs

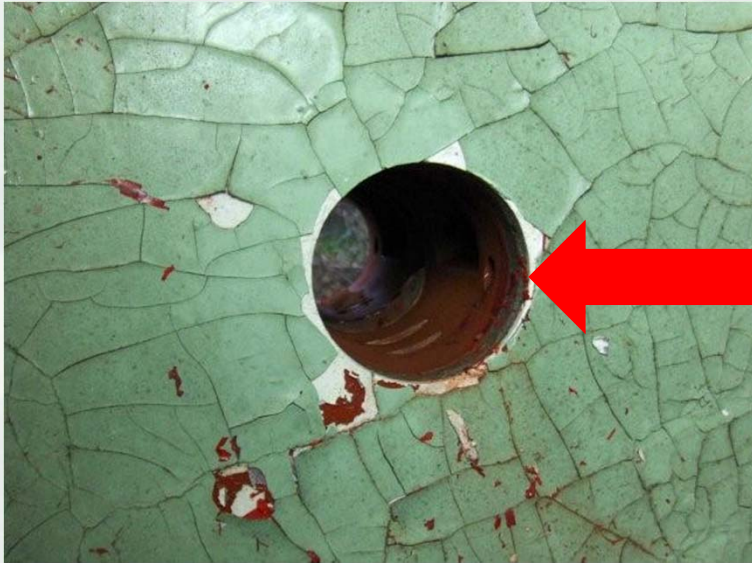
Some of these building materials were over 1 foot thick.

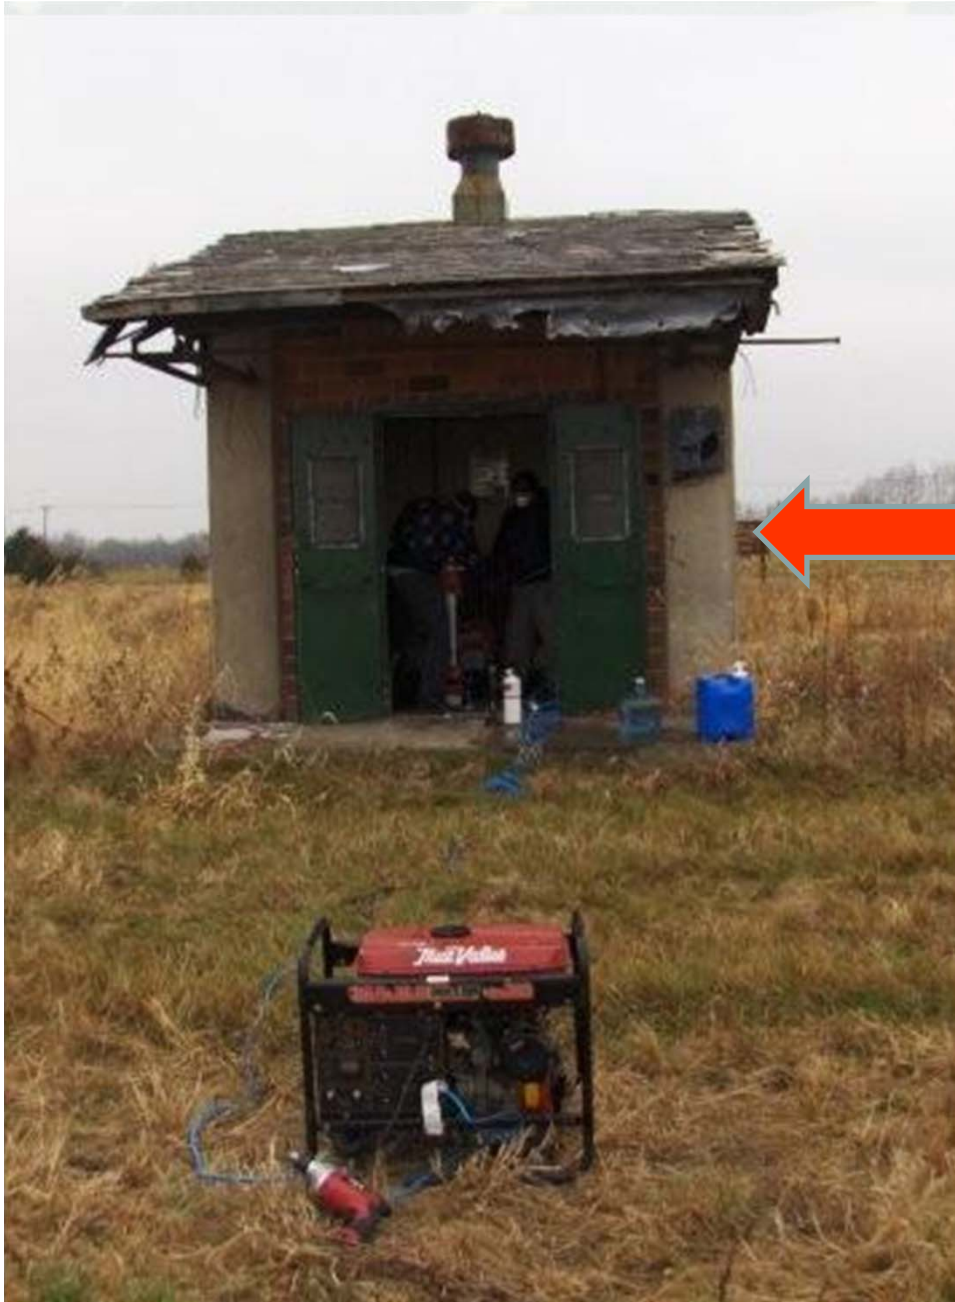
Samples Not Representative - The 2008 and 2009 concrete samples were not representative of the waste stream.

- Site ineligible for millions of dollars in FRP funds
- Buildings remain at site
